**SITE INSPECTION EXPANDED TRIP REPORT  
FOR  
JARD COMPANY, INC.  
SITE REASSESSMENT  
BENNINGTON, VERMONT**

**EPA REGION I SUPERFUND PROGRAM  
TRIP REPORT/CHECKLIST**

**Site Name:** Jard Company, Inc.  
**Address:** 259 Bowen Road  
**Town:** Bennington  
**State:** Vermont (VT)

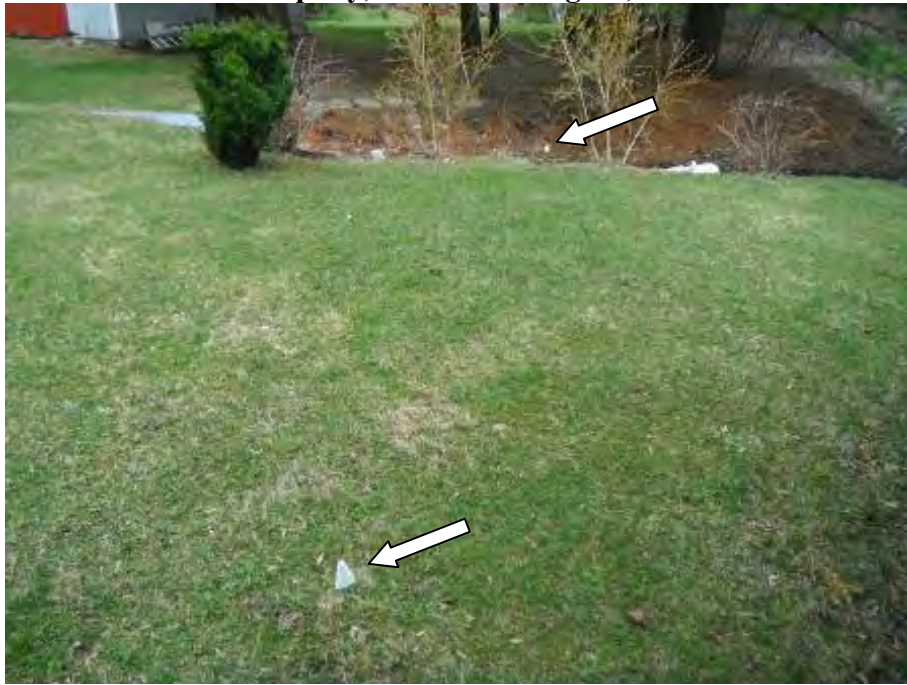
**FRAME NUMBER:** DSCF0501.JPG  
**PHOTOGRAPHY BY:** J. Saylor

**SCENE:** View of the stream channel north of the culvert on Property P005. In the foreground, surface soil sample location P005-SS-05 is visible; in the background, surface soil sample location P005-SS-06 is visible. Photograph taken facing west.

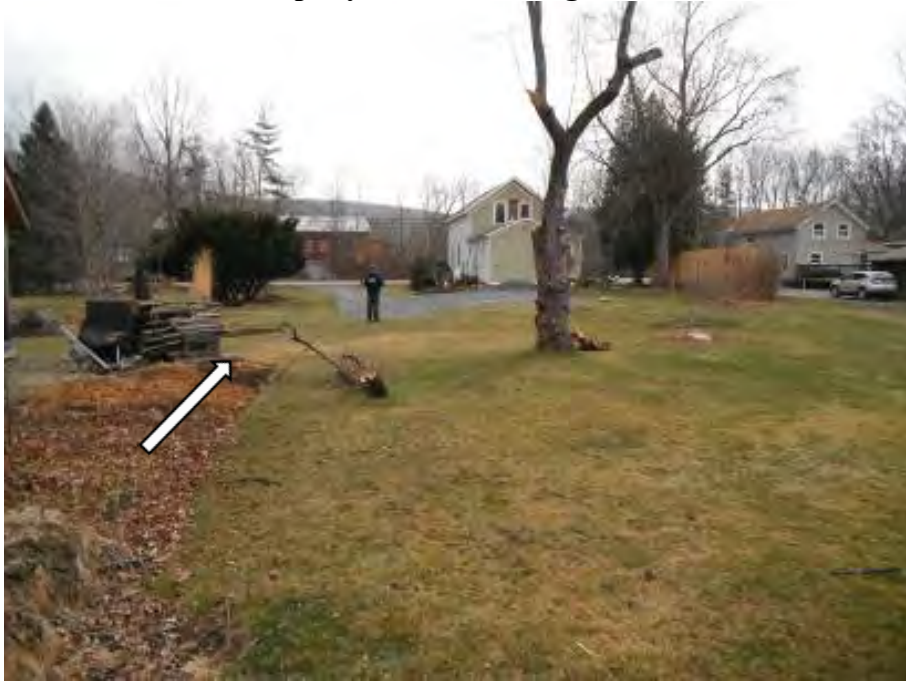
**FRAME NUMBER:** DSCF0447.JPG  
**PHOTOGRAPHY BY:** G. Hornok

**SCENE:** View of Property P006 from the western property boundary near the potentially impacted wetland parcel. Surface soil sample P006-SS-07 was collected from the compost pile/flower bed in the lower left corner of the photograph. A red maintenance garage is visible in the background. Photograph taken facing east.

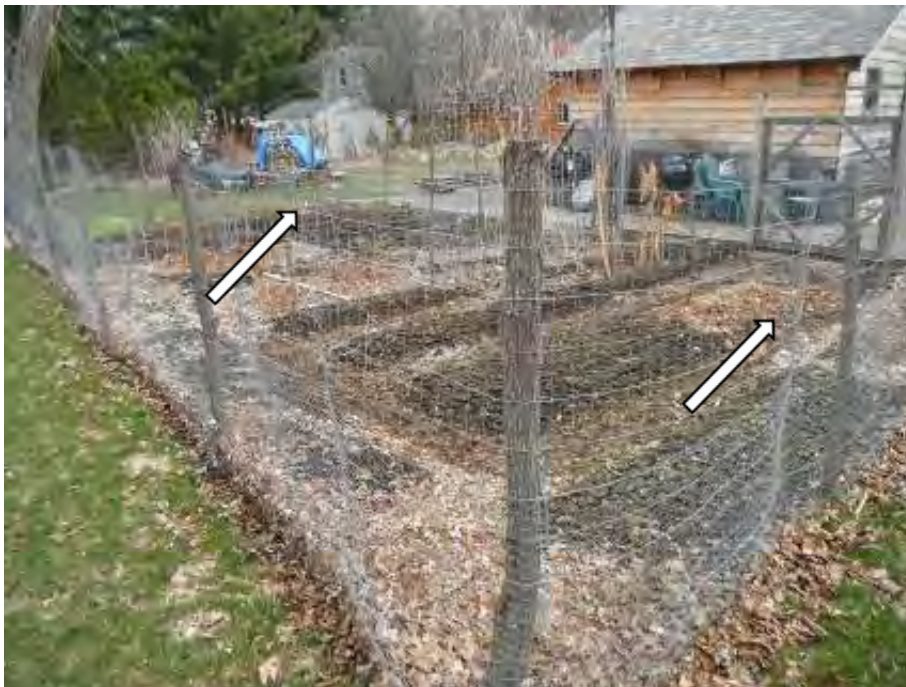
**FRAME NUMBER:** DSCF0450.JPG  
**PHOTOGRAPHY BY:** G. Hornok

**SCENE:** View of the rear of the shed with stored materials, and a vegetable garden located in the northwest corner of Property P006. Surface soil sample location P006-SS-10 is located in the northeast corner of the garden, demarcated with a white pin-flag; surface soil sample location P006-SS-09 is located in the corner of the garden adjacent to the gate. Property P005 is visible in the background.

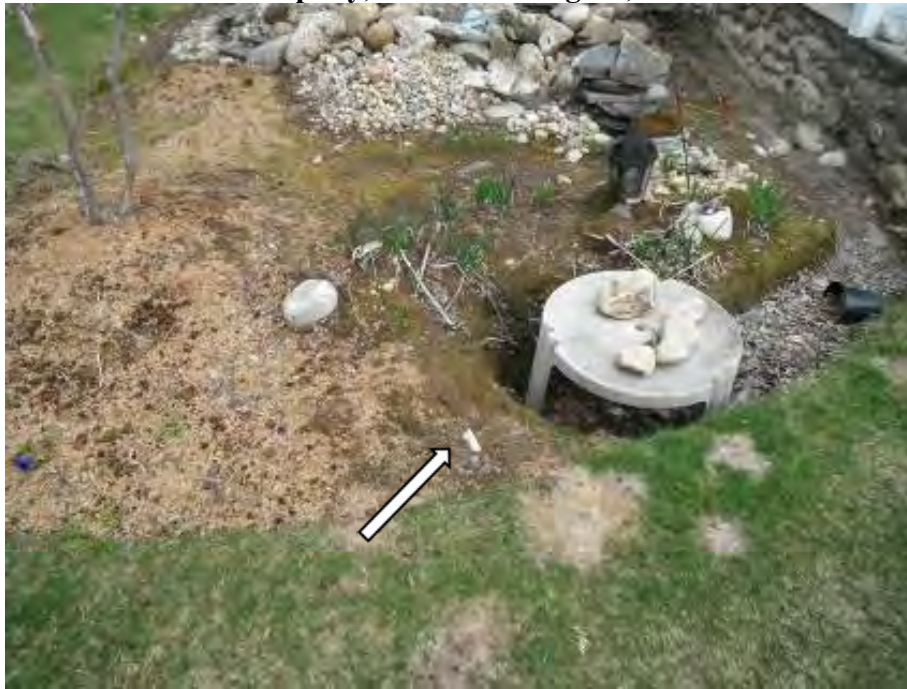
**SCENE:** View of drainage sump adjacent to the southeast corner of the residence located in Property P006. Sample location P006-SS-02 is visible to the left of the drainage sump. Photograph taken facing northwest.

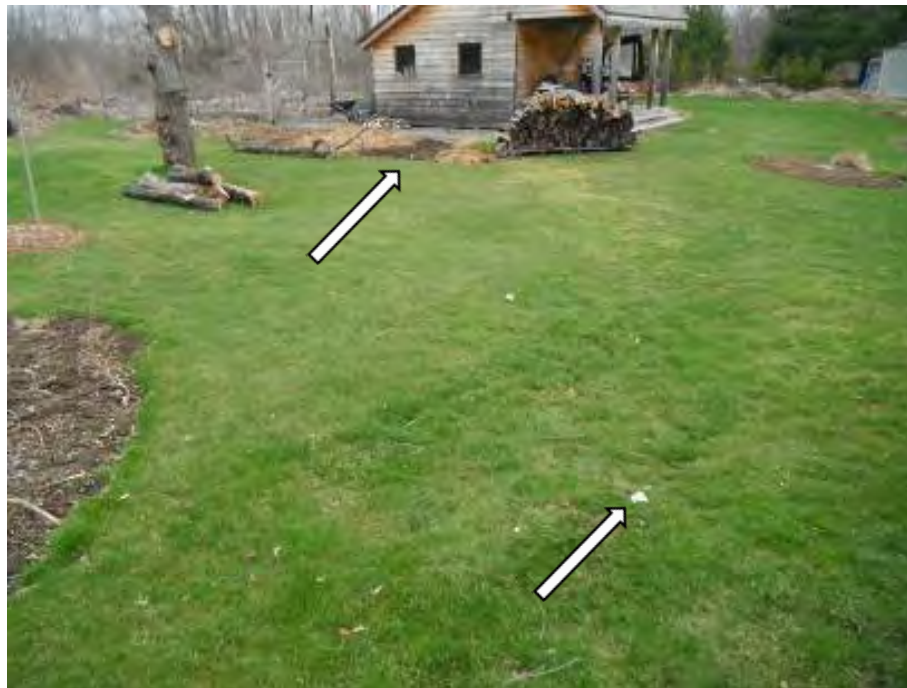
**FRAME NUMBER:** DSCF0505.JPG  
**PHOTOGRAPHY BY:** J. Saylor

**SCENE:** View of the northwest corner of Property P006. Several flower beds and gardens are scattered about the property. Surface soil sample P006-SS-06 is visible in foreground; surface soil sample location P006-SS-07 is visible in the flower bed in front of the shed. Photograph taken facing northwest.

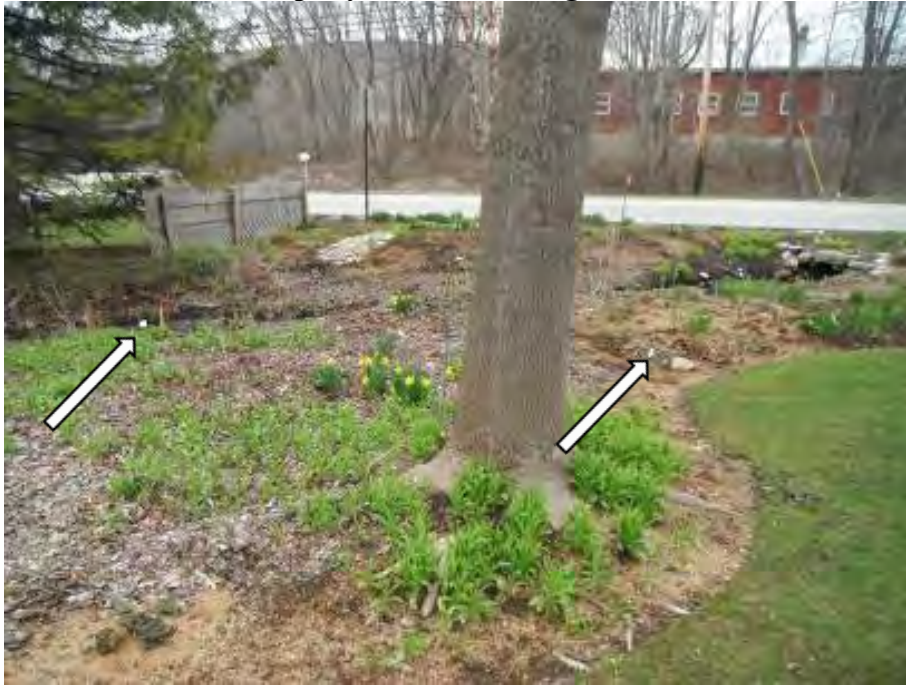
**FRAME NUMBER:** DSCF0509.JPG  
**PHOTOGRAPHY BY:** J. Saylor

**SCENE:** View of the northeast corner of Property P006. Property boundary stake is visible on the far side of the stream. A sediment sample location is visible along the stream bed, indicated by a white pin-flag and orange flagging. Surface soil sample location P006-SS-01 is visible to the right of the tree. Park Street is in the background. Photograph taken facing northeast.

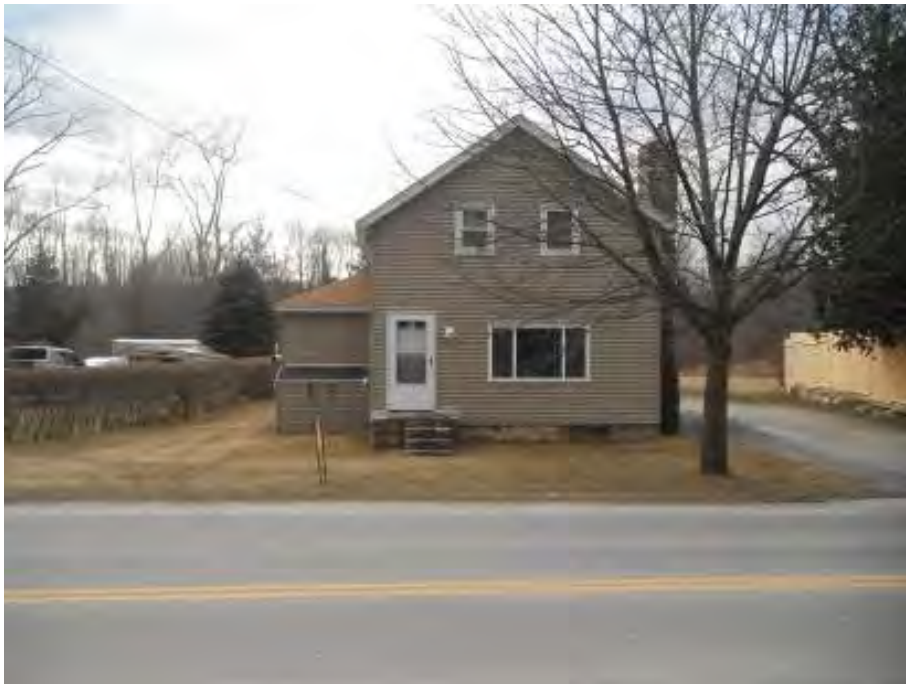
**FRAME NUMBER:** DSCF0388.JPG  
**PHOTOGRAPHY BY:** G. Hornok

**SCENE:** View of Property P007 from Park Street. Surface soil sample P007-SS-10 was collected behind the tree to the left of the gravel driveway. Photograph taken facing west from Park Street.

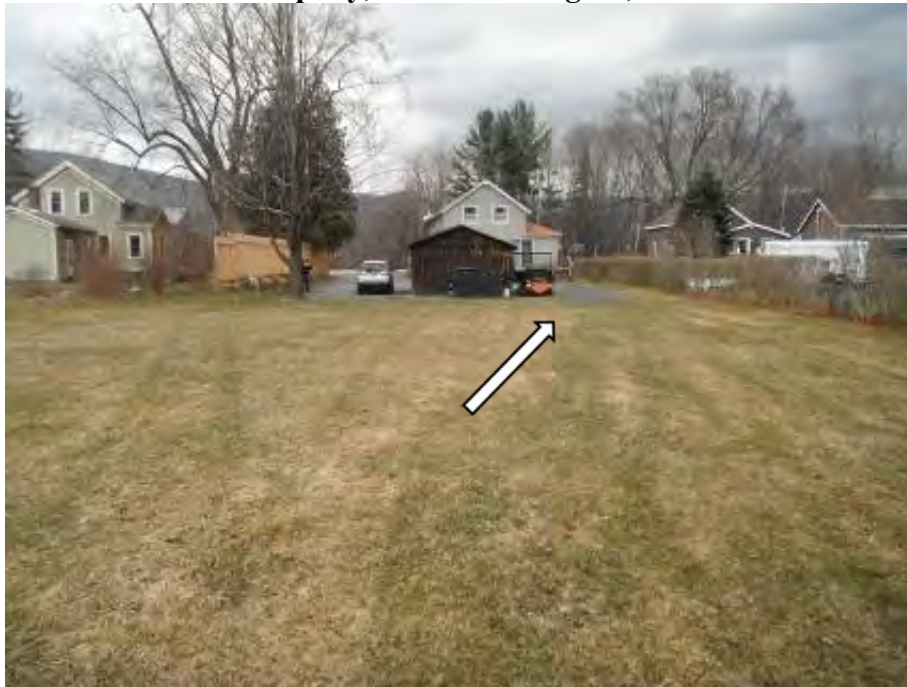
**FRAME NUMBER:** DSCF0446.JPG  
**PHOTOGRAPHY BY:** G. Hornok

**SCENE:** View of Property P007 taken from the western property boundary. Surface soil sample location P007-SS-06 is visible in the approximate center of the photograph. Photograph taken facing east.

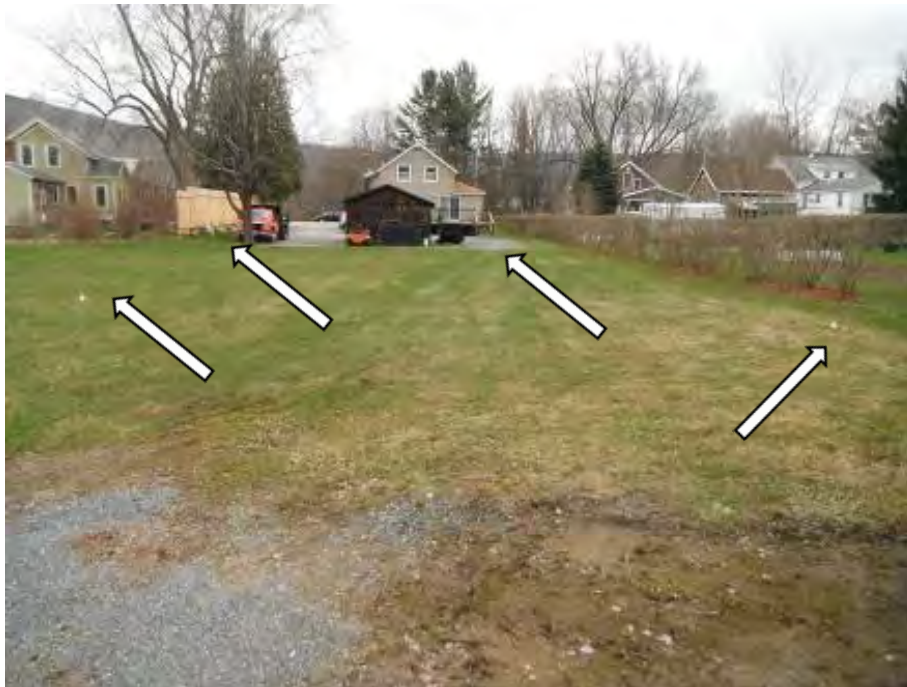
**FRAME NUMBER:** DSCF0514.JPG  
**PHOTOGRAPHY BY:** J. Saylor

**SCENE:** View of Property P007 taken from the western property boundary. Surface soil sample locations P007-SS-05, P007-SS-03, P007-SS-06, and P007-SS-09 are visible from left to right, respectively. Park Street is in the background. Photograph taken facing east.

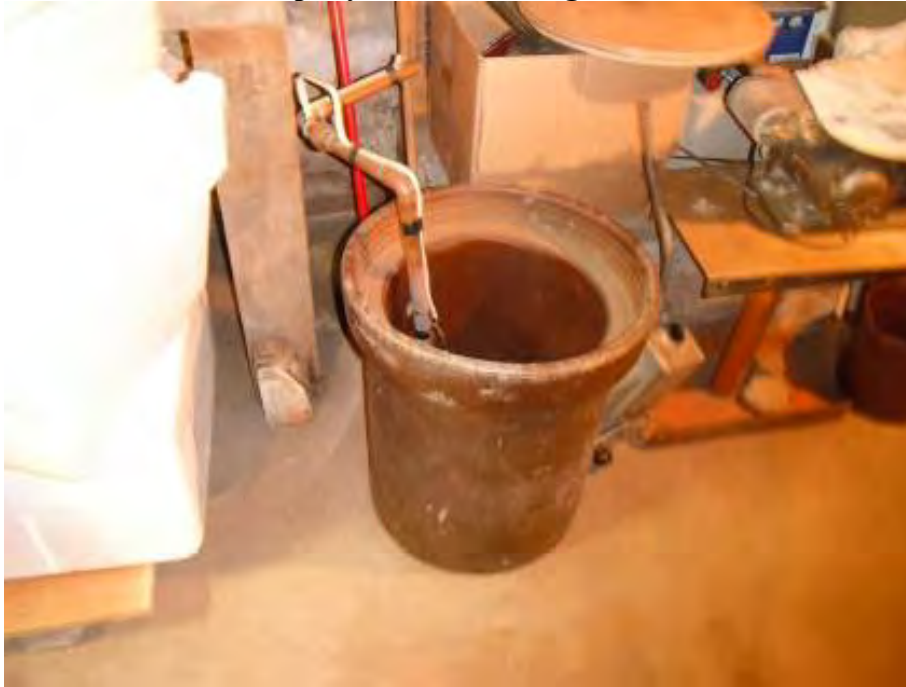
**SCENE:** View of the exterior of the former drinking water supply well located in the basement of the residence of Property P009.

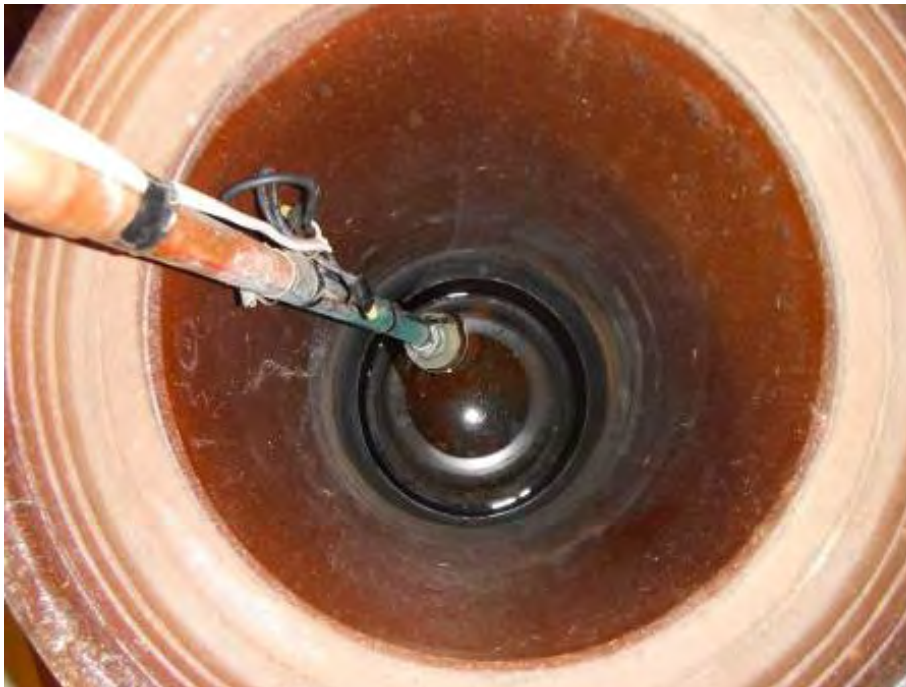
**SCENE:** View of the interior of the former drinking water supply well of Property P009 in the basement of the residence. Photograph taken facing down.

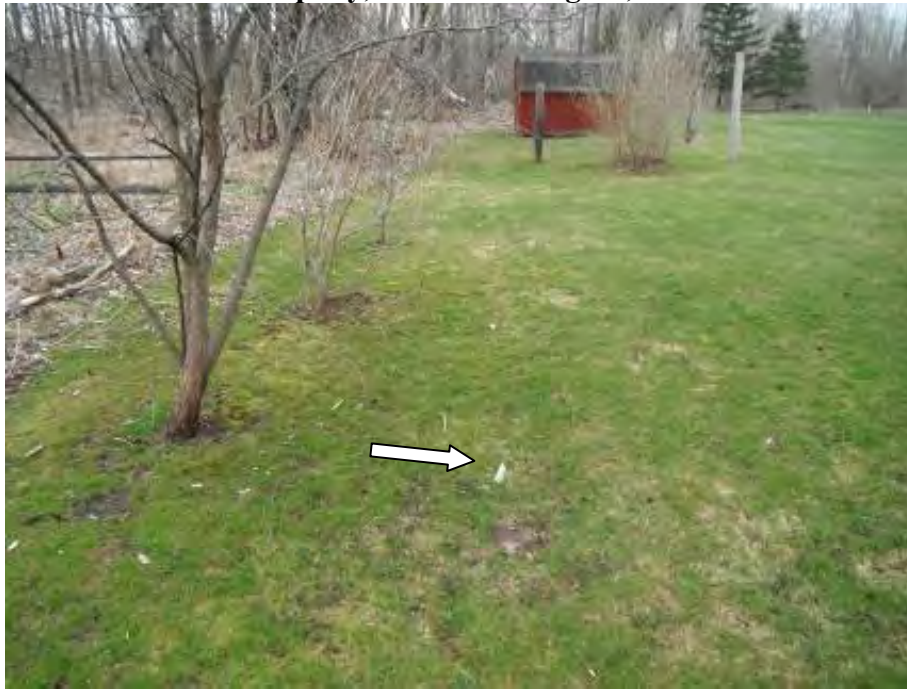
**FRAME NUMBER:** DSCF0519.JPG  
**PHOTOGRAPHY BY:** J. Saylor

**SCENE:** View of surface soil sample location P009-SS-05 adjacent to the southern property boundary. A storage shed is visible in the background. Photograph taken facing west.

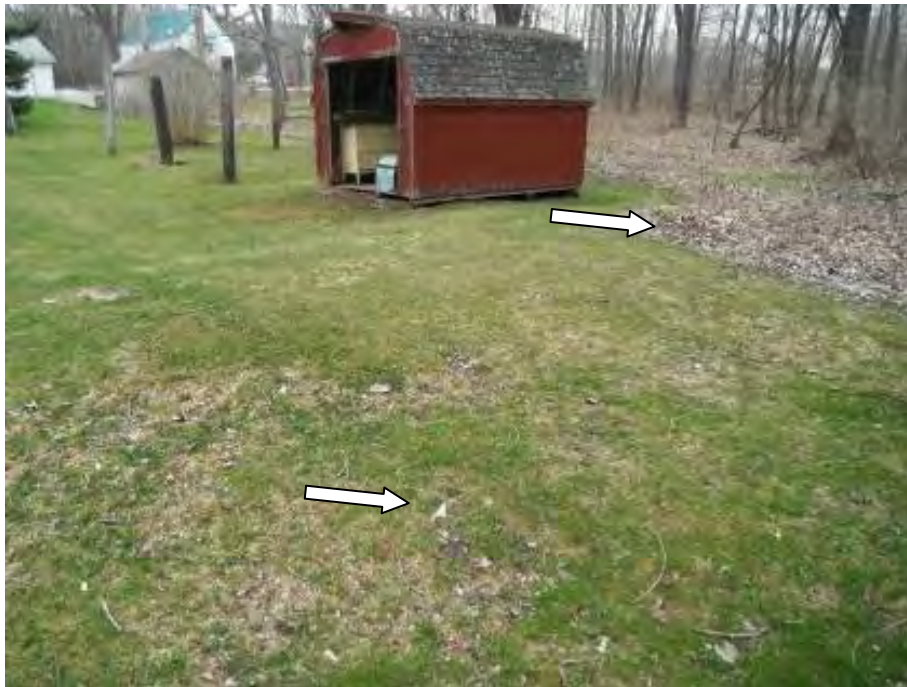
**FRAME NUMBER:** DSCF0521.JPG  
**PHOTOGRAPHY BY:** J. Saylor

**SCENE:** View of the southwest corner of Property P009. Surface soil sample location P009-SS-11 is in foreground; surface soil sample location P009-SS-07 is in the leaf pile/brush to the right of the storage shed. Photograph taken facing southeast.

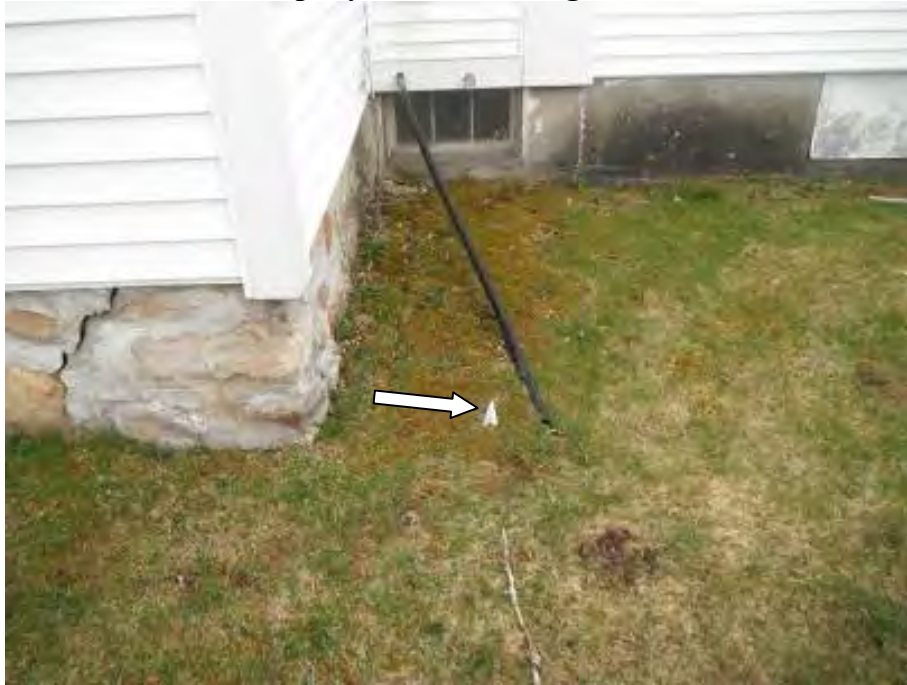
**SCENE:** View of P009-SS-03 near sump pump drainage piping along the northern edge of the residence of Property P009. The septic tank (not in photograph) is to the right of the drainage piping. Photograph taken facing south.

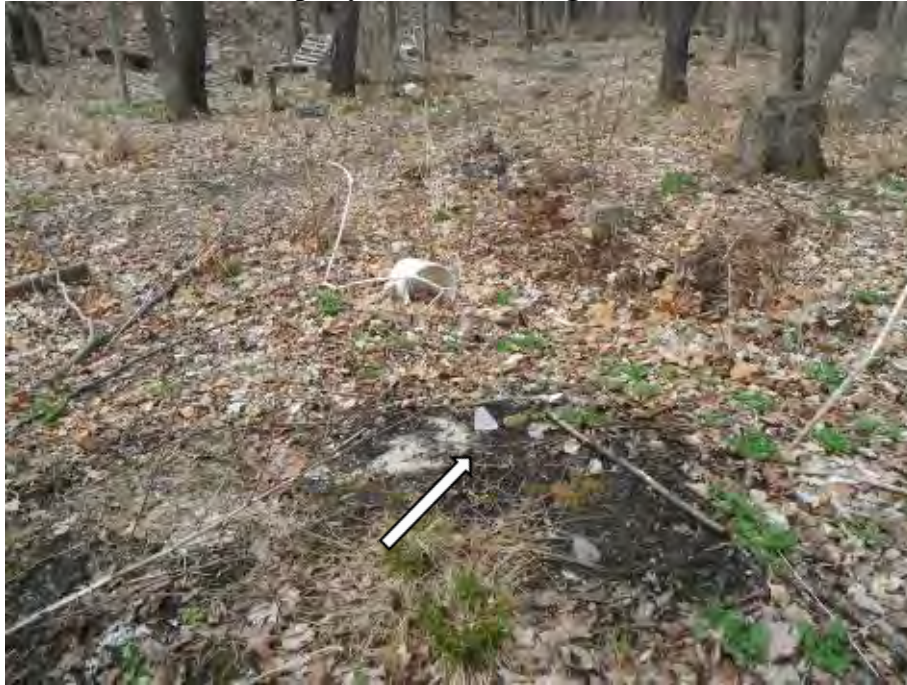
**SCENE:** View of ash pile and P010-SS-06 in the western portion of Property P010. Monitoring well EPA-107 is visible in the far background. The slope in the upper left corner is the toe of the berm. Photograph taken facing west.

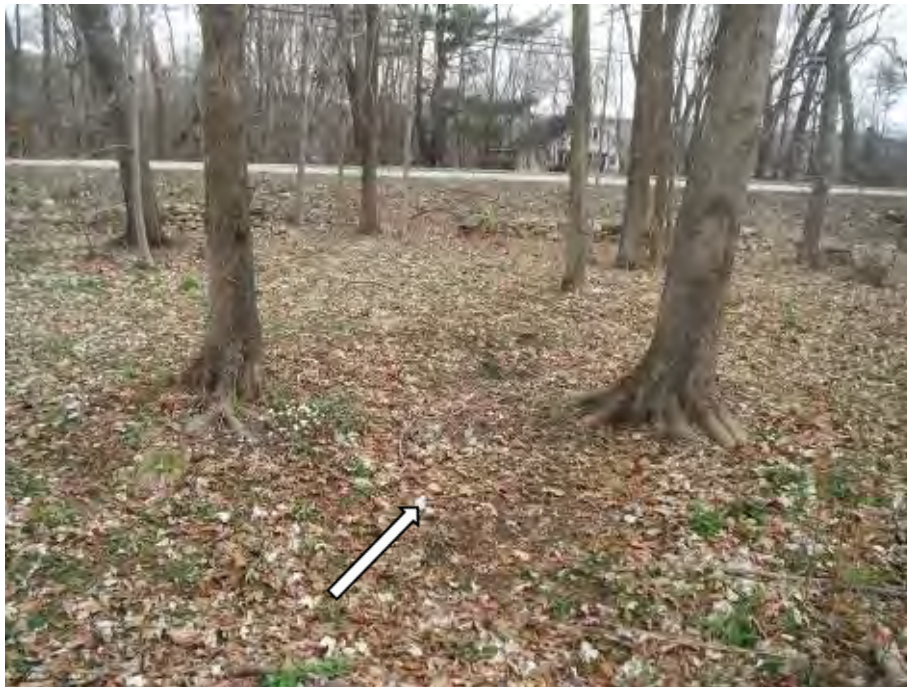
**FRAME NUMBER:** DSCF0532.JPG  
**PHOTOGRAPHY BY:** J. Saylor

**SCENE:** View of surface soil sample location P010-SS-04 in the side yard on Property P010. Park Street and an additional residence (P011) is visible in the background. Photograph taken facing east.

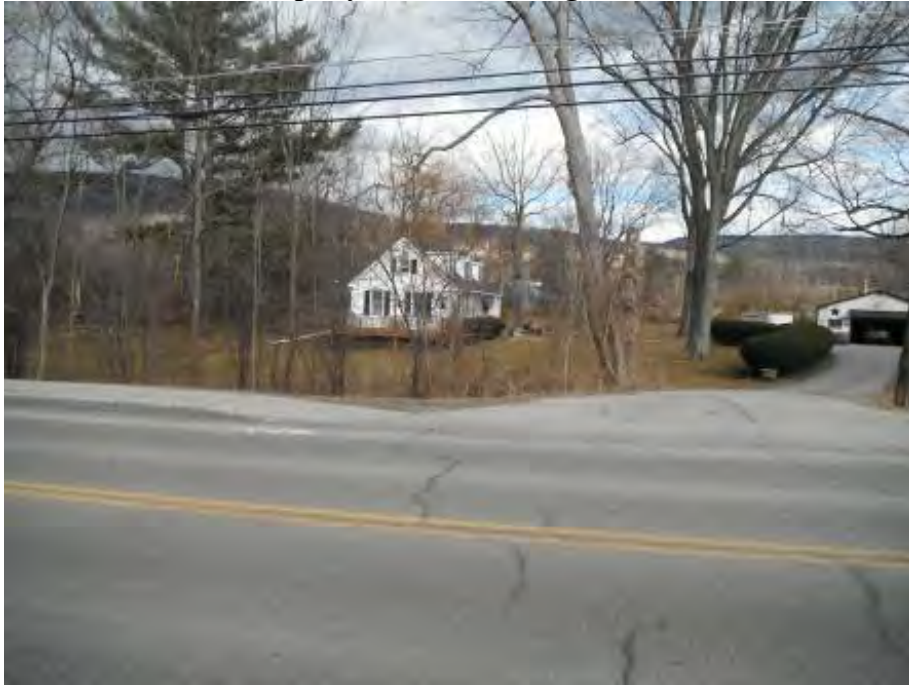
**FRAME NUMBER:** DSCF0384.JPG  
**PHOTOGRAPHY BY:** G. Hornok

**SCENE:** View of Property P011 from the west side of Park Street. The white polyvinyl chloride (PVC) sump pump drainage piping is visible off the left corner of the residence. The athletic fields are visible in the background behind the garage. Photograph taken facing east.

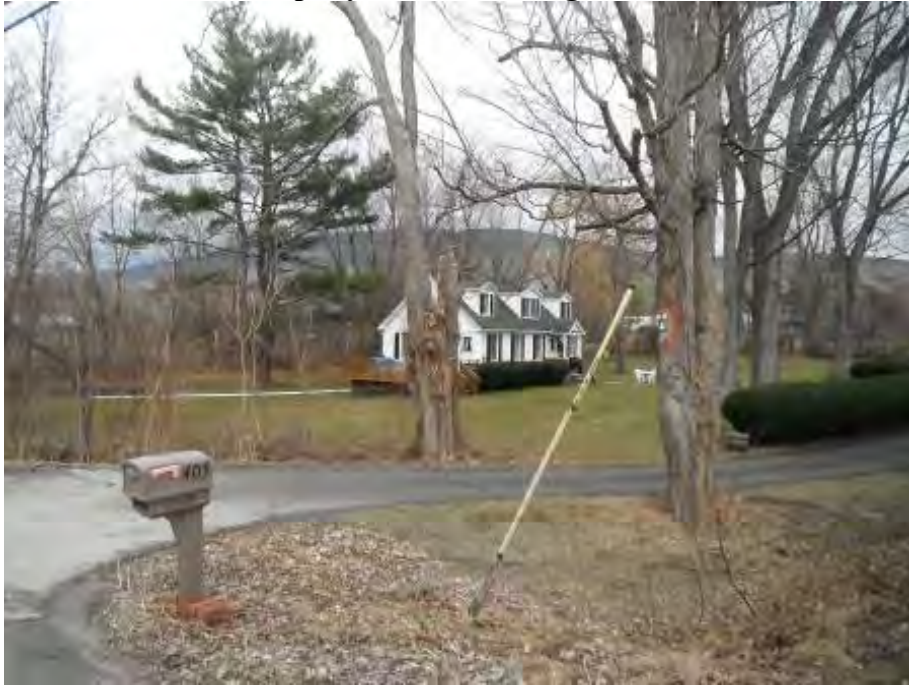
**FRAME NUMBER:** DSCF0460.JPG  
**PHOTOGRAPHY BY:** R. Sharp

**SCENE:** View of Property P011 from the east side of Park Street. The white PVC sump pump drainage piping is visible off the left corner of the residence. The athletic fields are visible in the background, to the right of the residence. Photograph taken facing northeast.

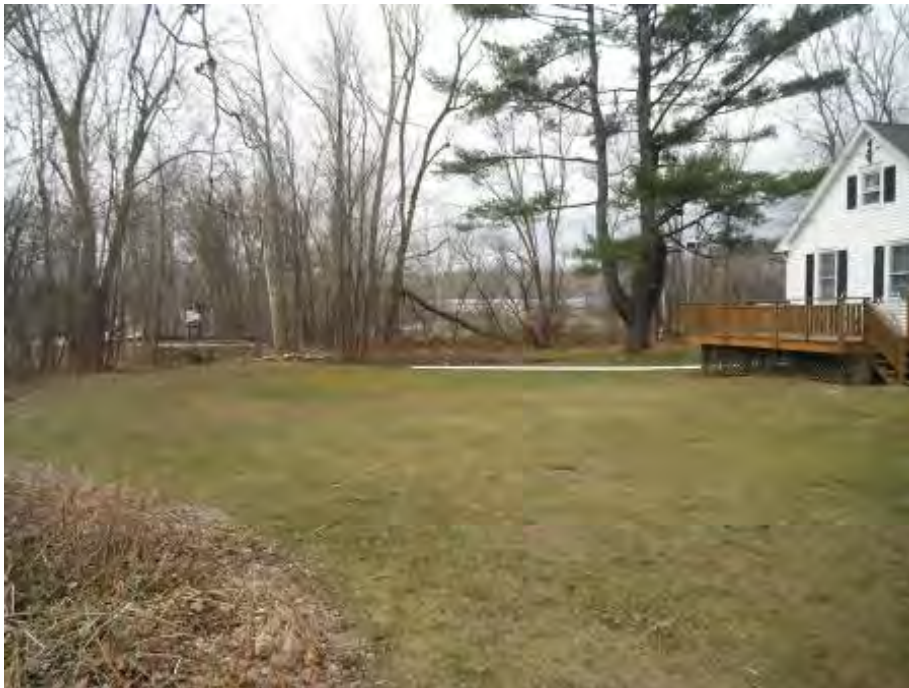
**FRAME NUMBER:** DSCF0461.JPG  
**PHOTOGRAPHY BY:** R. Sharp

**SCENE:** View of the western portion of Property P011. White PVC sump pump drainage piping is visible behind the porch. The entrance to the athletic fields and the culvert running underneath the entrance is visible to the left, just beyond the small pond. Photograph taken facing north.

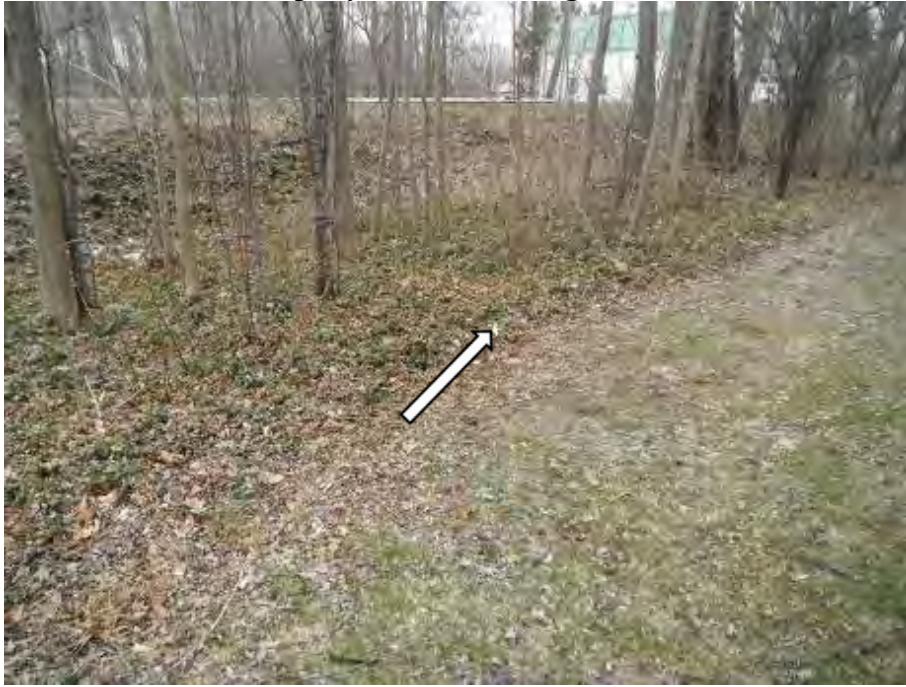
**FRAME NUMBER:** DSCF0462.JPG  
**PHOTOGRAPHY BY:** R. Sharp

**SCENE:** View of the western property boundary adjacent to Park Street. Property P010 is visible to the right. Surface soil sample location P011-SS-03 (arrow) is in grassy area in foreground. Photograph taken facing northwest.

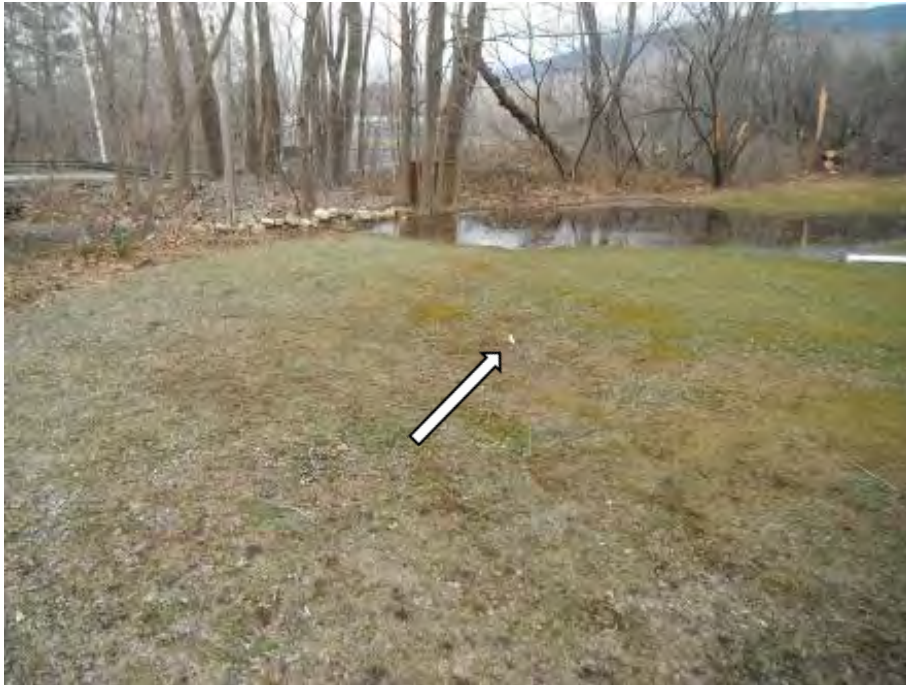
**SCENE:** View of the northwestern corner of Property P011, with standing water at the end of the outflow from the sump pump drainage. Surface soil sample location P011-SS-06 is in a small depression in the center of the photograph. Water drains to the small pond (headwaters for unnamed stream) to left near culvert. Photograph taken facing north.

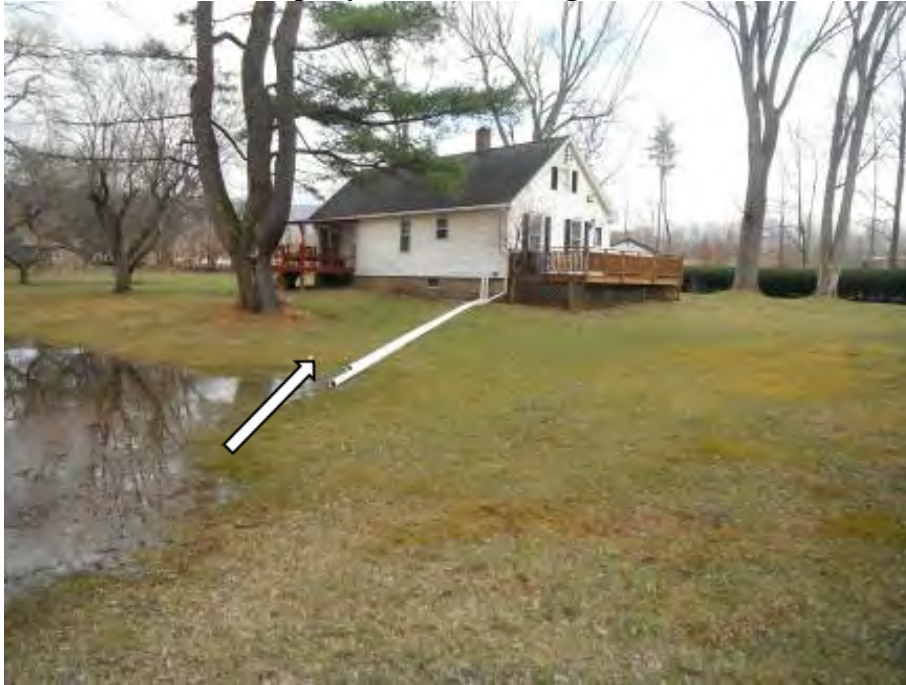
**FRAME NUMBER:** DSCF0463.JPG  
**PHOTOGRAPHY BY:** R. Sharp

**SCENE:** View from the northwest corner of Property P011. There is standing water from the sump pump drainage piping/outflow visible in the left corner of the photograph. Surface soil sample location P011-SS-08 is visible left of the PVC piping. Photograph taken facing southeast.

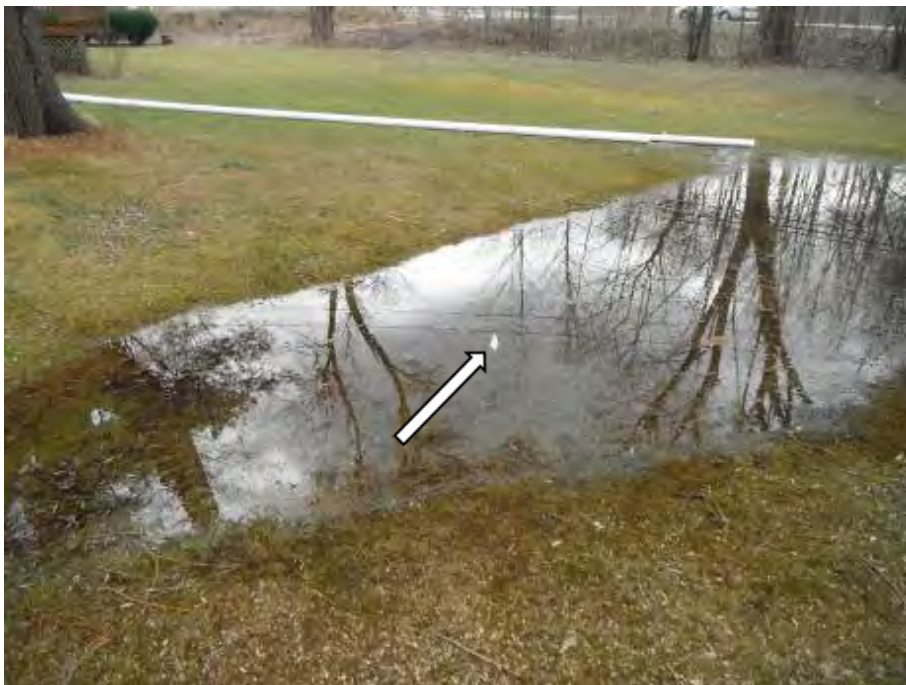
**FRAME NUMBER:** DSCF0466.JPG  
**PHOTOGRAPHY BY:** R. Sharp

**SCENE:** View of surface soil sample location P011-SS-10 along the edge of the drainage area with standing water at Property P011. Park Street is visible in the background. Photograph taken facing southwest.

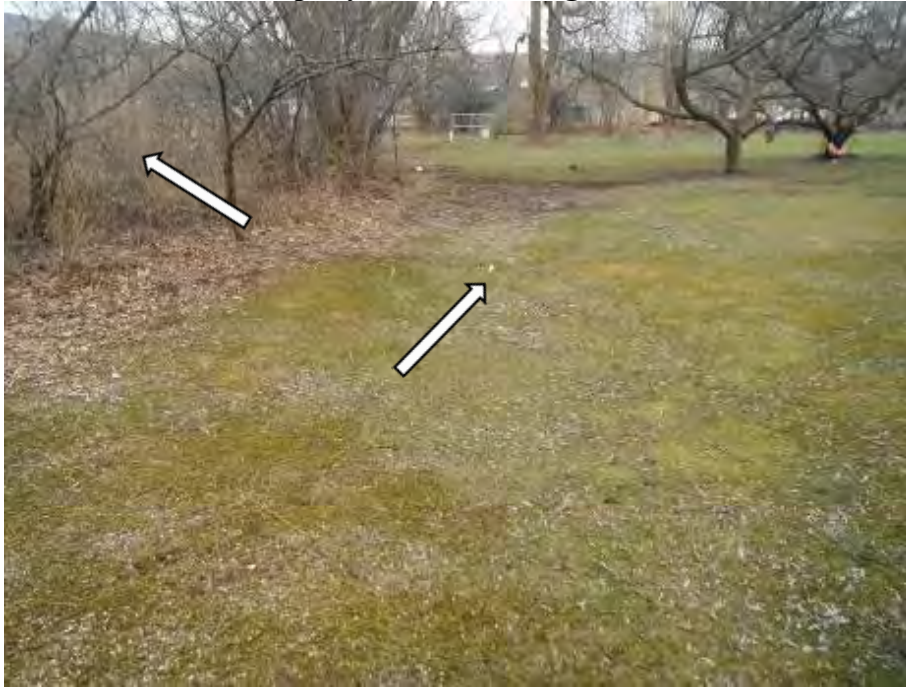
**FRAME NUMBER:** DSCF0469.JPG  
**PHOTOGRAPHY BY:** R. Sharp

**SCENE:** View of the edge of the brush in the northern portion of Property P011. Surface soil sample location P011-SS-01 is visible in the slight depression in the center of the photograph. Surface soil sample location P011-SS-09 is located in the brush to the left. The athletic fields are visible in the background beyond the dog kennel area. Photograph taken facing east.

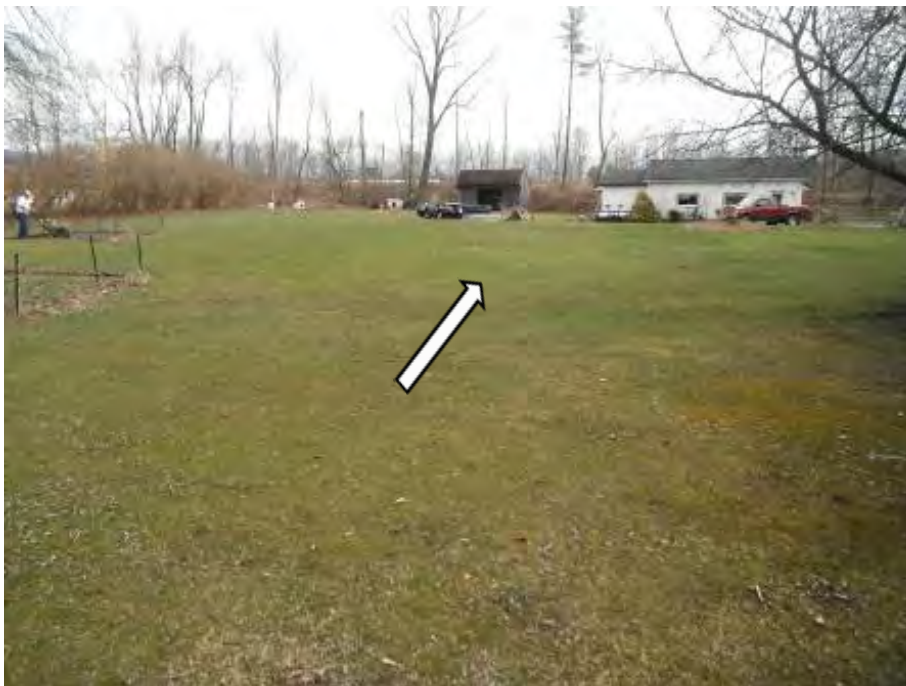
**FRAME NUMBER:** DSCF0470.JPG  
**PHOTOGRAPHY BY:** R. Sharp

**SCENE:** View of the eastern portion of Property P011. Surface soil sample location P011-SS-04 is located west of the two gardens to the left. The levee for the Walloomsac River is visible just beyond the garage, shed, and dog kennel area. Photograph taken facing south.

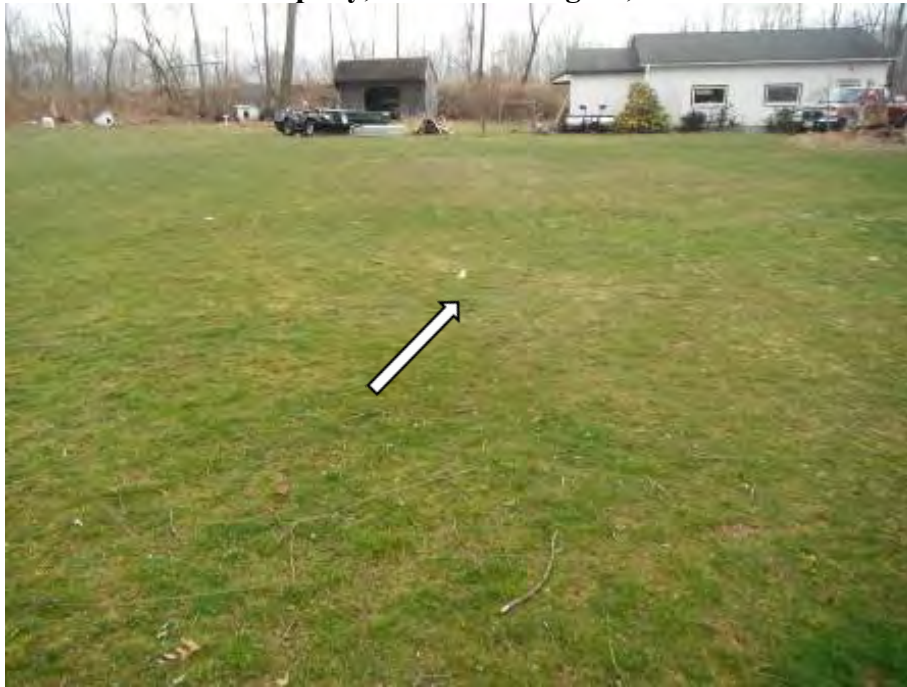
**FRAME NUMBER:** DSCF0473.JPG  
**PHOTOGRAPHY BY:** R. Sharp

**SCENE:** View of the eastern portion of Property P011. Surface soil sample location P011-SS-04 is located just west of two gardens to the left (arrow). The levee for the Walloomsac River is visible just beyond the garage, shed, and dog kennel area. Photograph taken facing south.

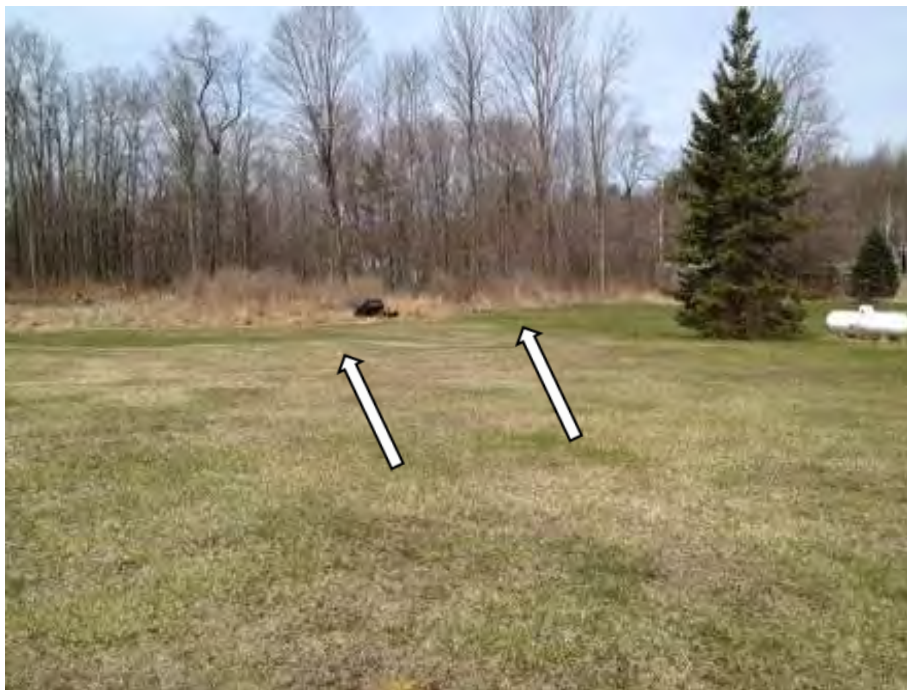
**FRAME NUMBER:** DSCF0474.JPG  
**PHOTOGRAPHY BY:** R. Sharp

**SCENE:** View of surface soil sampling locations P020-SS-01 and P020-SS-02 (from left to right) in a grassy area between the two residences located at Property P020. To the right, there is an aboveground storage tank with fuel for one of the residences on the property. North Branch Road is visible in the background to the right. Photograph taken facing northwest.

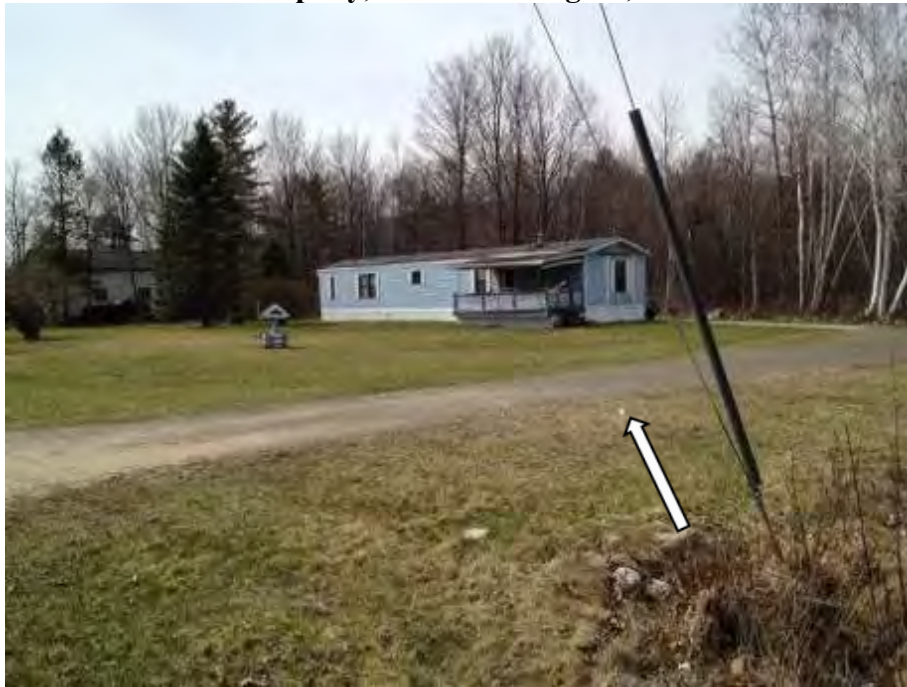
**FRAME NUMBER:** CS\_Photos 024.JPG  
**PHOTOGRAPHY BY:** C. Scesny

**SCENE:** View of the southern portion of Property P020. There is a stream (not in photograph) separating Property P020 from the adjacent residence. Surface soil sampling location P020-SS-06 is visible to the left of the guy-wire support for the utility pole. Photograph taken facing southwest.

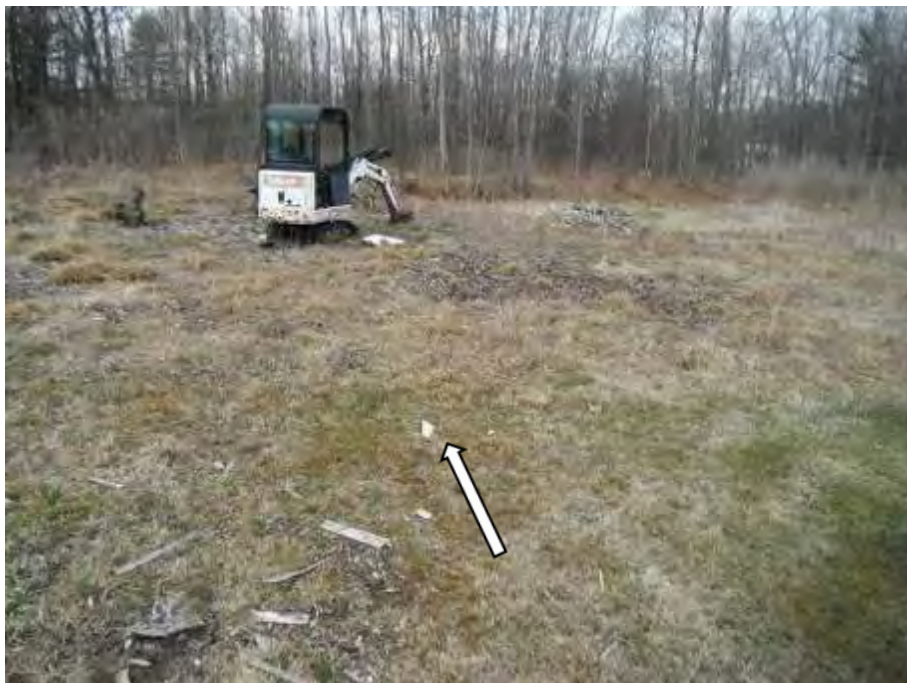
**FRAME NUMBER:** CS\_Photos 028.JPG  
**PHOTOGRAPHY BY:** C. Scesny

**SCENE:** View of a portion the western property boundary in Property P020. Surface soil sample location P020-SS-01 is visible in foreground. Behind the sample location, there is an excavator parked in a small woodchip pile. Photograph taken facing west.

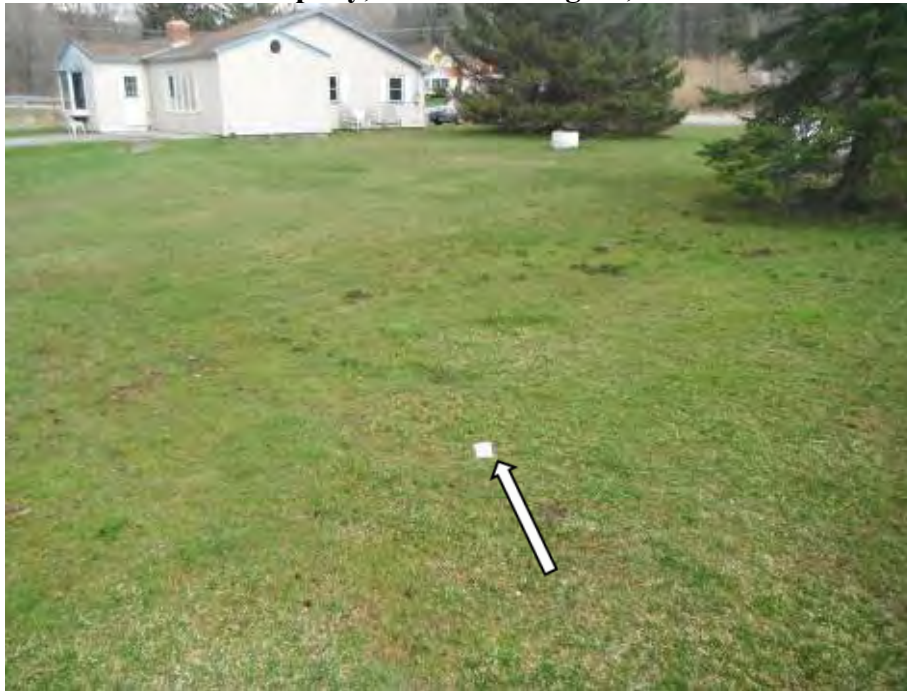
**FRAME NUMBER:** DSCF0534.JPG  
**PHOTOGRAPHY BY:** J. Saylor

**SCENE:** View of surface soil sample location P020-SS-01 and the northern residence in Property P020. There are several large trees visible to the right. North Branch Road is visible to the left of the residence, and Bowen Road is visible to the right of the residence. Photograph taken facing north.

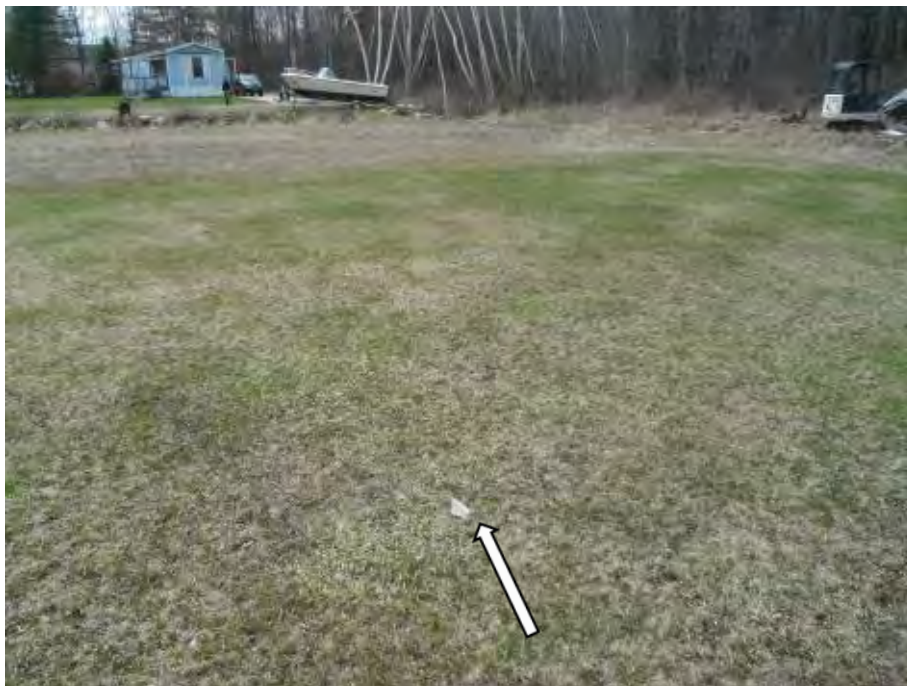
**FRAME NUMBER:** DSCF0536.JPG  
**PHOTOGRAPHY BY:** J. Saylor

**SCENE:** View of surface soil sample location P020-SS-03 with an excavator to the right near the edge of the wooded area. The southern residence in Property P020, a parked vehicle, and a stored boat are visible on the far side of a stream separating the two residential lots. Photograph taken facing southwest.

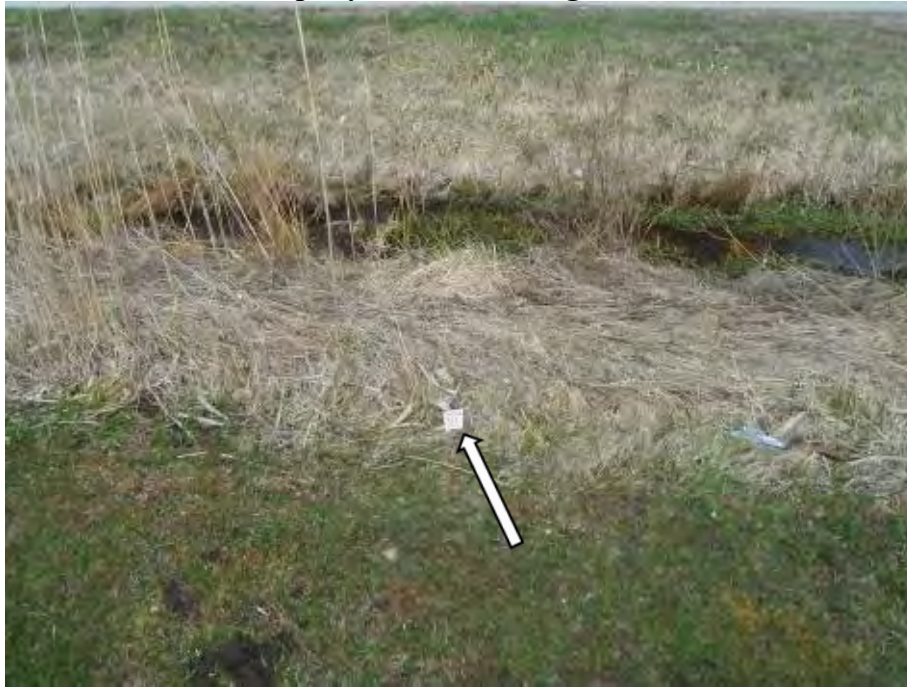
**FRAME NUMBER:** DSCF0537.JPG  
**PHOTOGRAPHY BY:** J. Saylor

**SCENE:** View of P020-SS-08, south of the stream separating the two residential lots on Property P020. There is a wooded area to the west of the location (not visible). Photograph taken facing north.
